3. IDENTIFICATION AND DESCRIPTION OF THE PROBLEM

3.3. Storm Sewer System Deficiencies

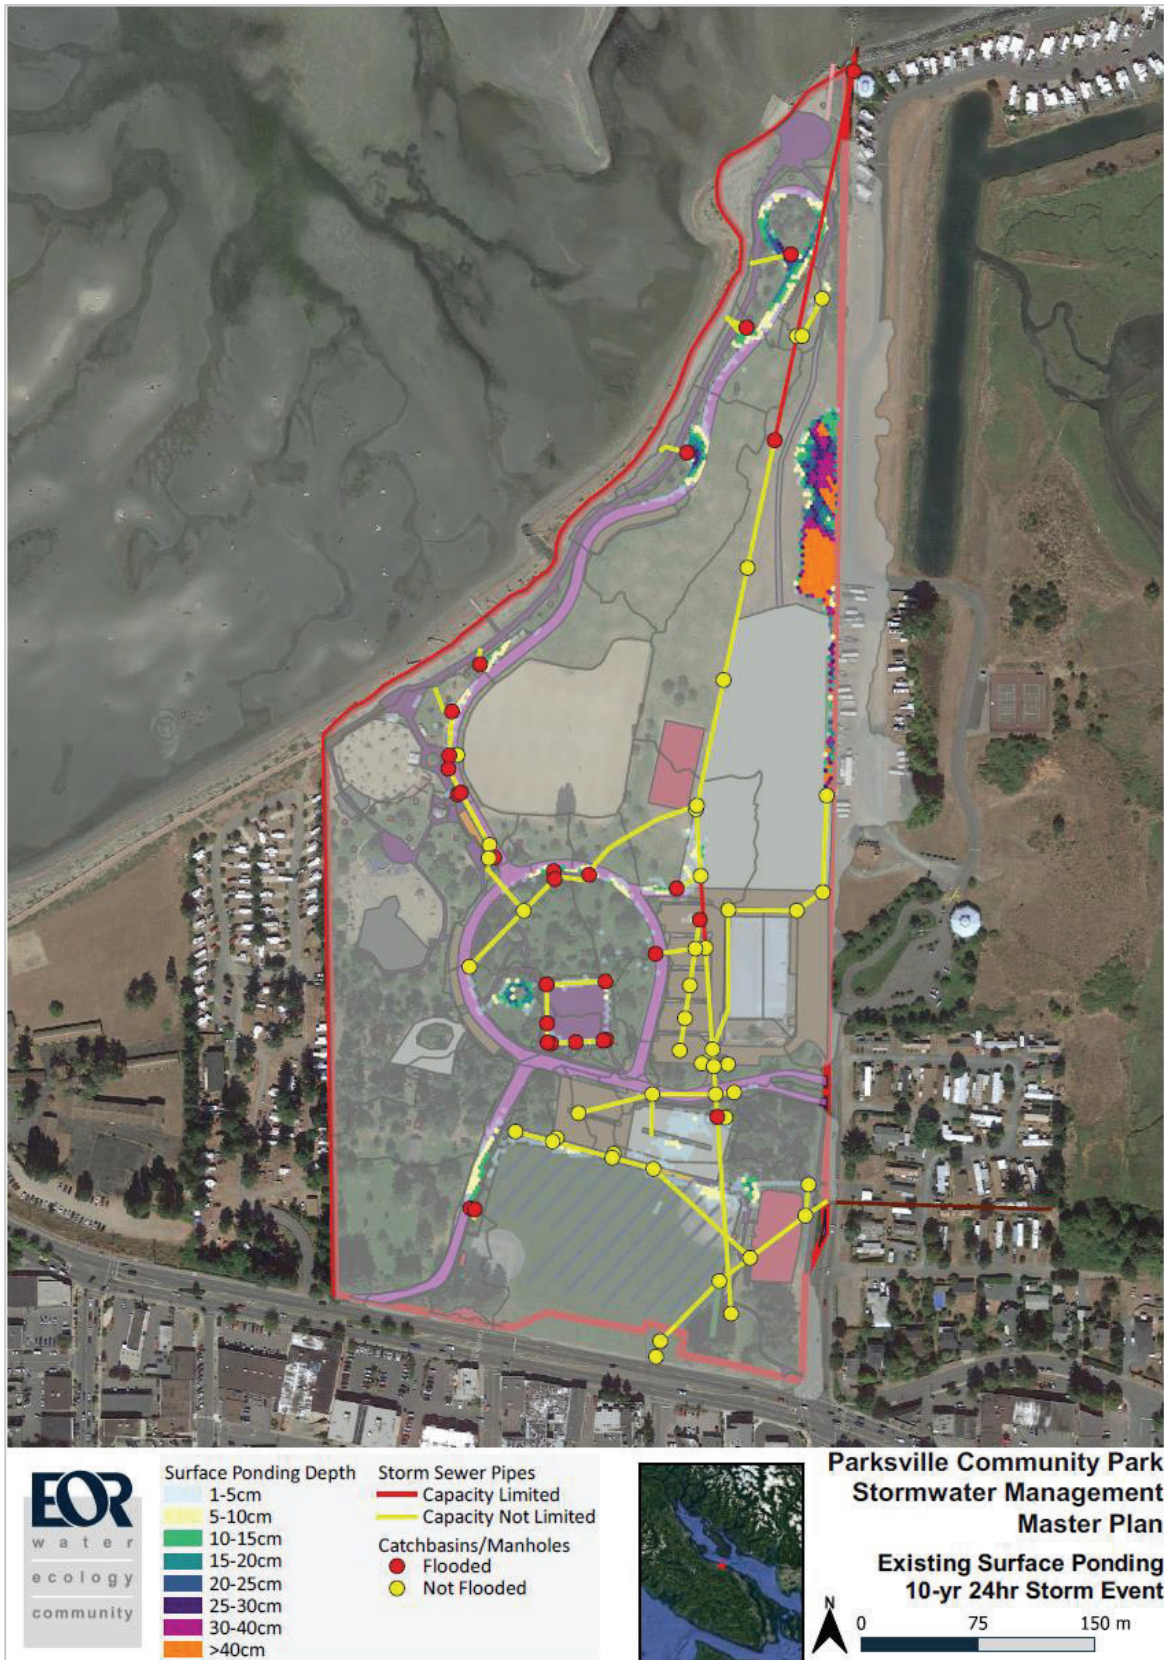
Figure 21. Existing Conditions Model Results during 10-Year 24-Hour SCS Type 1A Pacific Coast Rainfall Event

24-hour SCS Type 1A Pacific Coast storm is critical for both the minor system (10-year return period) and the major system (100-year return period), causing more ponding than shorter duration, more intense events. System deficiencies during both events are summarized in Table 6 and illustrated in Figure 21 and Figure 22. Ponding depths in Figure 21 and Figure 22 were derived from 2D modeling estimates of water depth across the ground surface represented by the digital elevation model (DEM). In support of anecdotal evidence, the continuous simulation model highlighted that late summer short duration, high intensity events exceed the inlet and pipe capacity of the system.

Rainfall Event	% of CBs & MHs Flooded	% of Pipe Length with Limited Capacity	Total Area of Road Flooding
10-year 24-hour SCS Type 1A Pacific Coast	37.5	13.5	1843 m ² > 0.06 m deep
100-year 24-hour SCS Type 1A Pacific Coast	45.8	28.2	1384 m ² > 0.15 m deep
