**Arrowsmith Water Service  
Operations Year in Review  
January 9, 2023**

# Arrowsmith Water Service

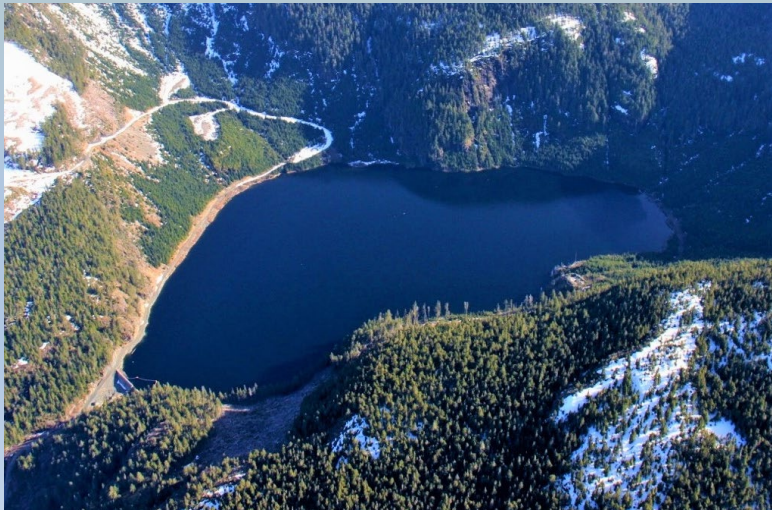
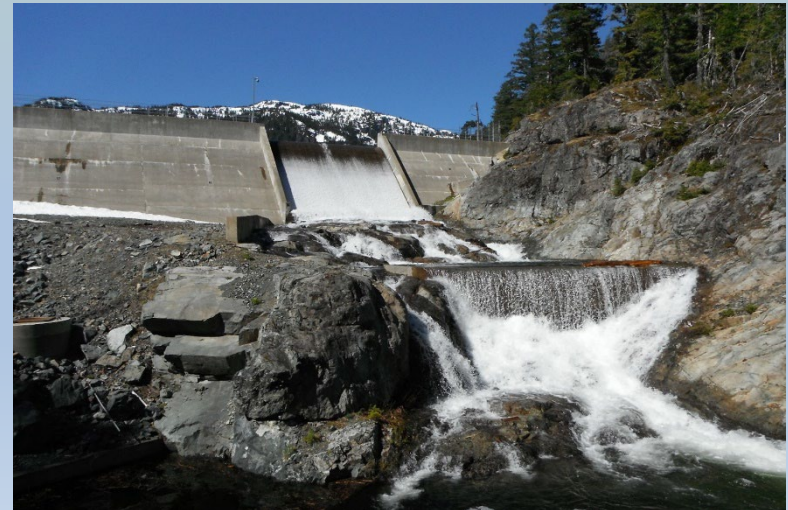
## Location of Snow Pillow Gauge, Dam and River Gauge

ARROWSMITH LAKE DAM  
ELV = 828.50m

NEARBY SNOW STATION  
ELV = 1,465m

- Arrowsmith Lake catchment area: 5 square kilometers
- Englishman River catchment area: 391 square kilometers

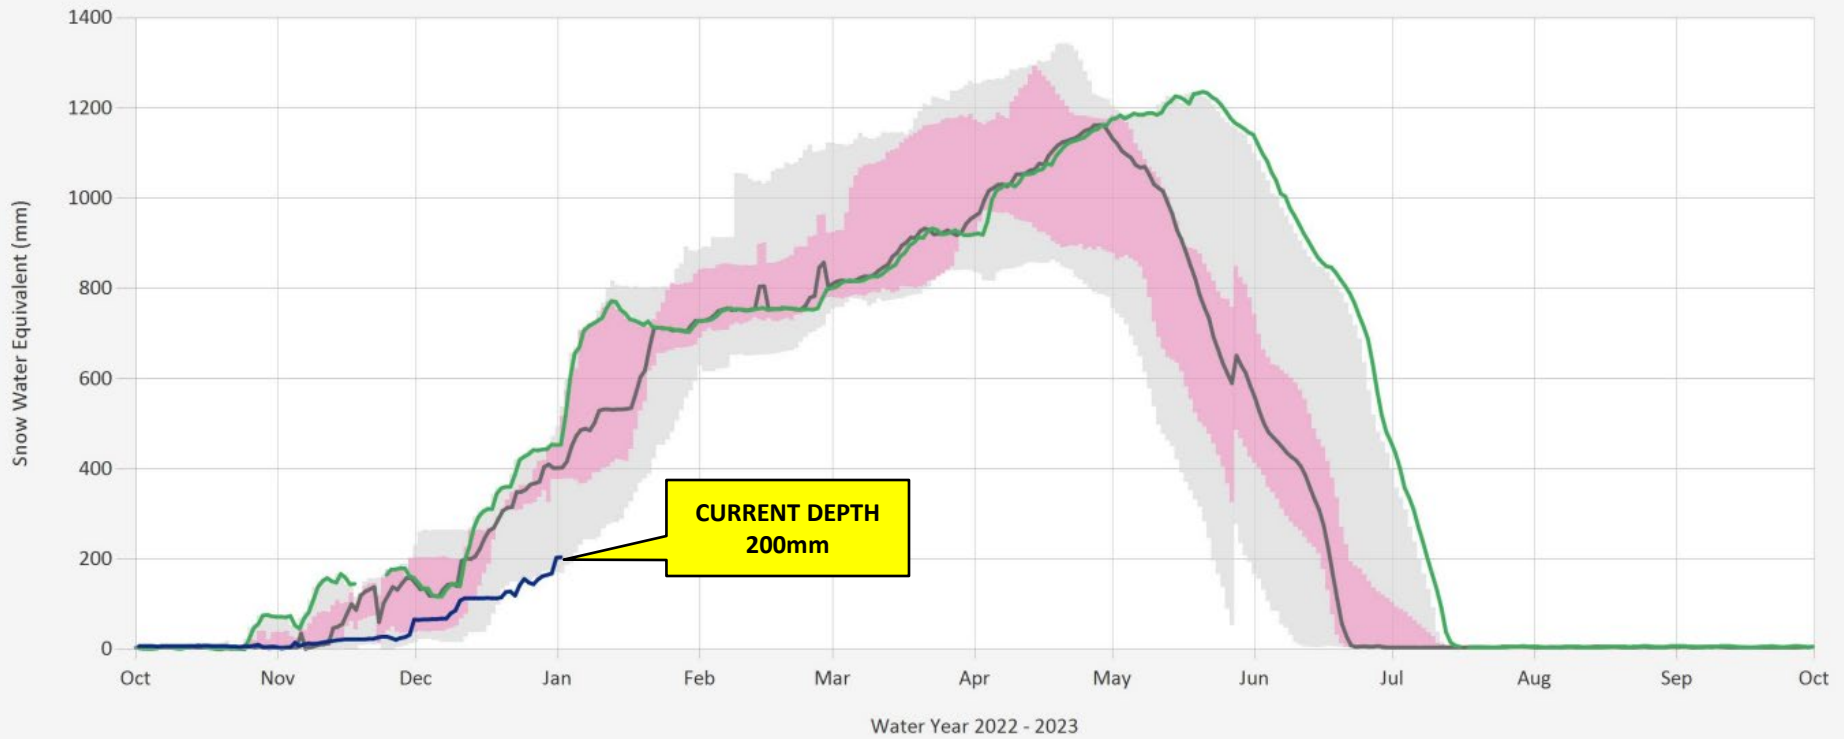
# Snow Pillow Gauge 3B26P Historical Records

Source Data: SW.Daily@3B26P Location: Mount Arrowsmith, Latitude: 49.207376, Longitude: -124.567776, Elevation: : 1465 m

— 2022 - 2023 — 2021 - 2022 — Historical Daily Median — Historical 25-75 — Range of Min & Max (Jul 14, 2017 - Sep 30, 2022)

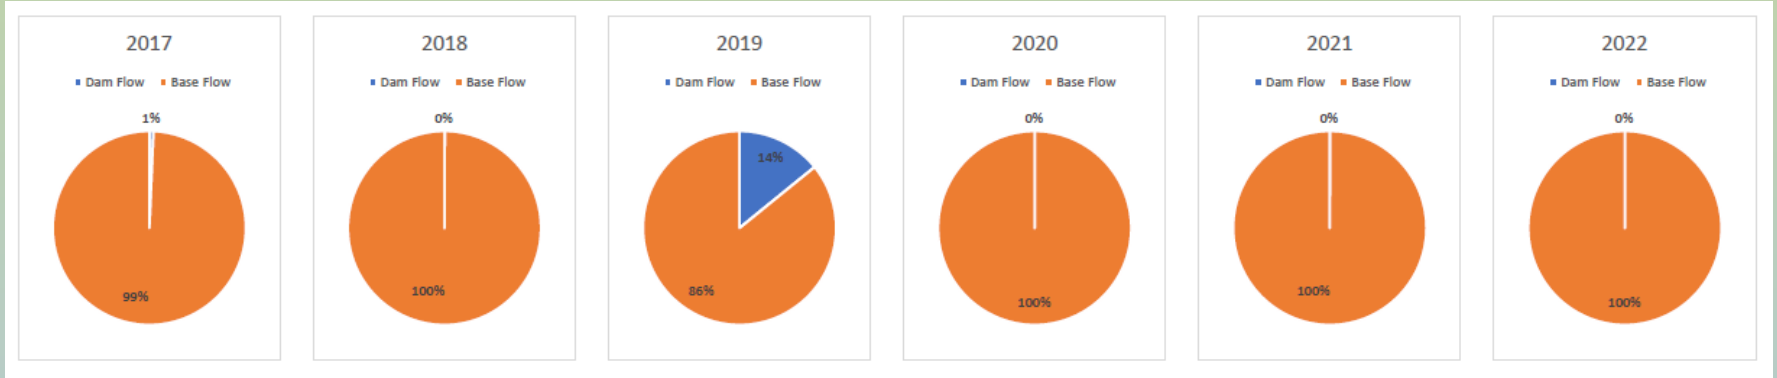
## June 2017-2022

# 2017-2022 Englishman River Base Flow

June	July	August	September	October
Historical (2017-2021)	2.0 m <sup>3</sup> /s 6.0 m <sup>3</sup> /s	0.5 m <sup>3</sup> /s 2.6 m <sup>3</sup> /s	0.2 m <sup>3</sup> /s 2.4 m <sup>3</sup> /s	0.3 m <sup>3</sup> /s 11.0 m <sup>3</sup> /s	1.2 m <sup>3</sup> /s 34.9 m <sup>3</sup> /s
2022	4.4 m <sup>3</sup> /s 20.6 m <sup>3</sup> /s	1.1 m <sup>3</sup> /s 8.2 m <sup>3</sup> /s	0.2 m <sup>3</sup> /s 1.0 m <sup>3</sup> /s	0.1 m <sup>3</sup> /s 0.2 m <sup>3</sup> /s	0.1 m <sup>3</sup> /s 0.2 m <sup>3</sup> /s

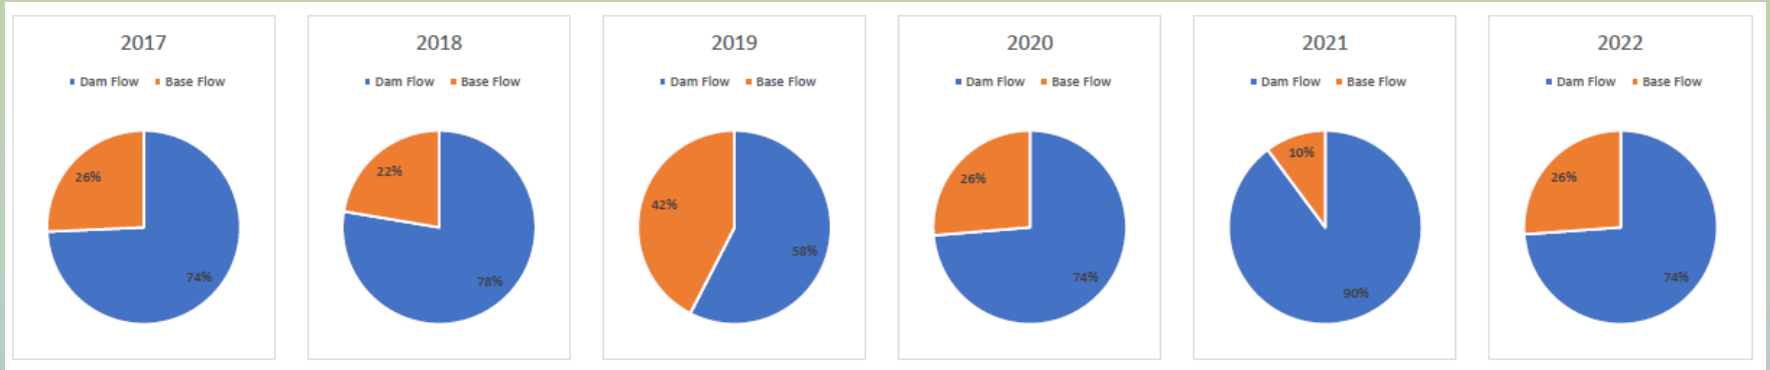
## August 2017-2022

# 2017-2022 Englishman River Base Flow

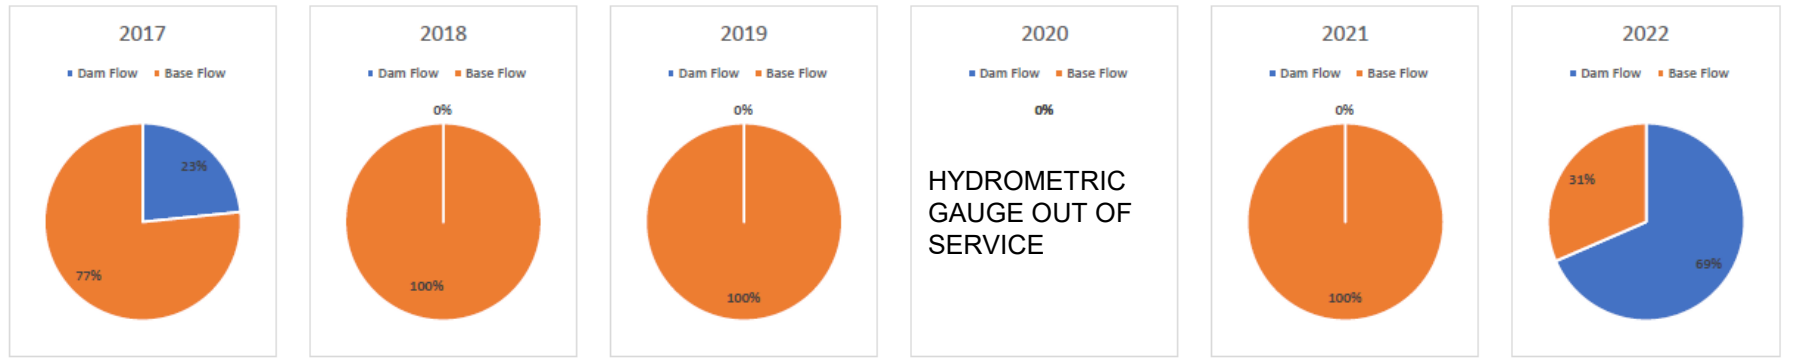
October 2017-2022

# 2017-2022 Englishman River Base Flow

- September and October river baseflow was very abnormal. Arrowsmith Dam became the main supplier.
- Note: opposite 2021 Heat Dome with early heat and early rains

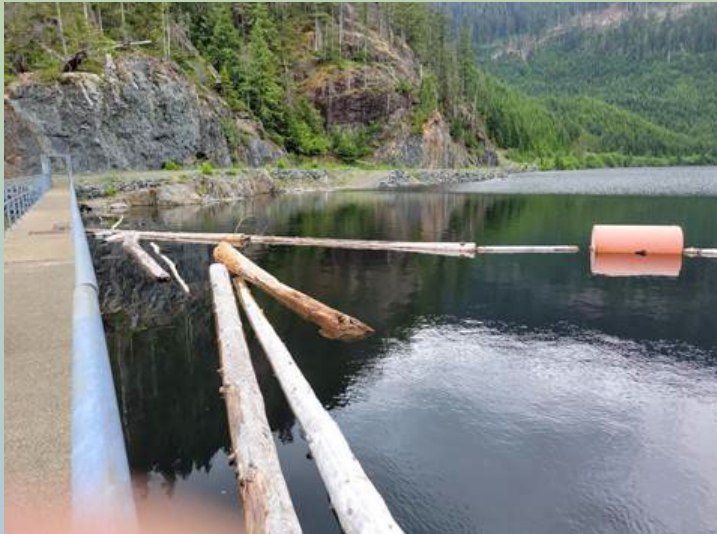
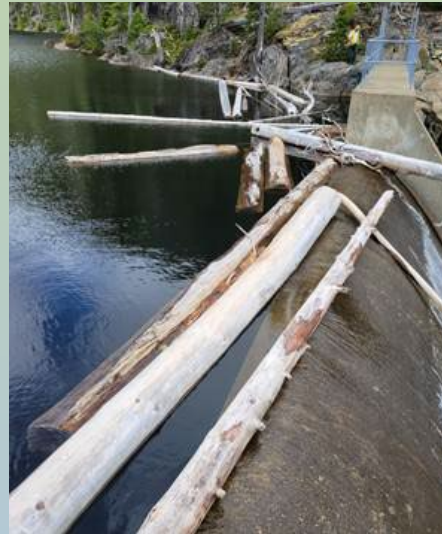
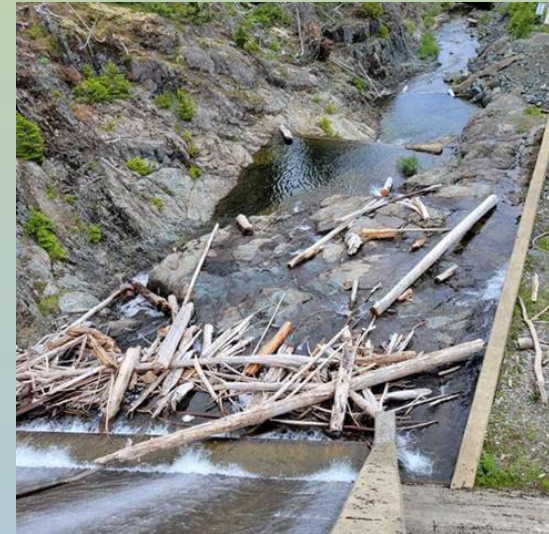
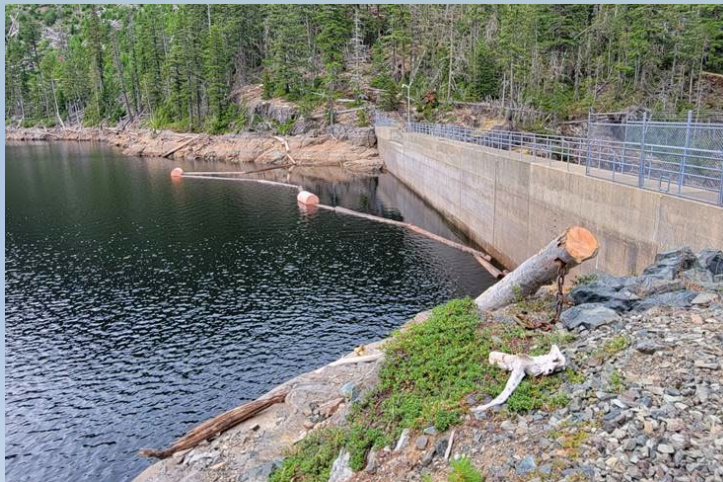
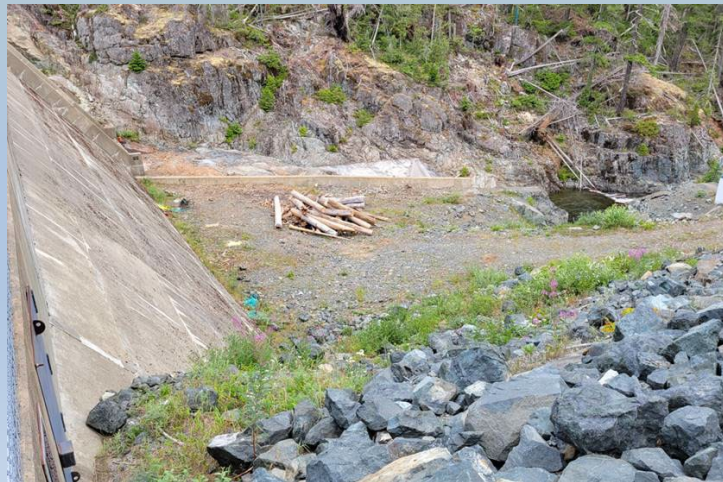
# Debris Removal and Log Boom Repair

- Major storm events damaged the log boom. Inspection and repair was completed in August/September 2022.
- Replacement will be required in the future as the logs are nearing their end of life.

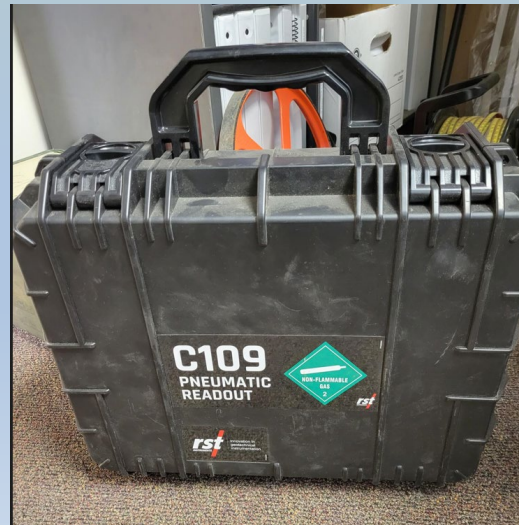
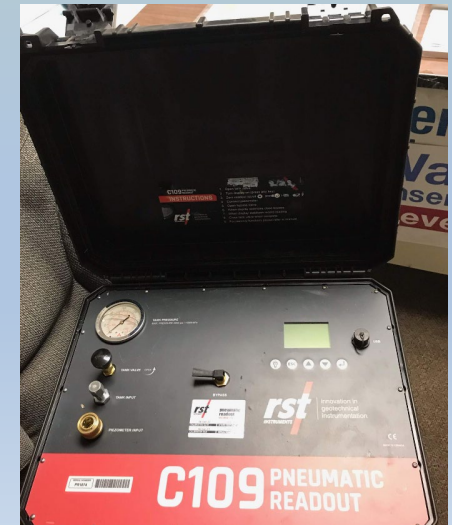
## Piezometer Readout Unit – Completed

The unit is needed to upkeep with the regular monitoring work required per the Provincial Dam Regulation.
