## 2. CURRENT AND FUTURE CONDITIONS

This section summarizes the future environment in the study area (Figure 1) relevant to stormwater management planning to maintain the expected level of service under future conditions. The environment of Parksville Community Park includes the physical, social, cultural, and natural environments. The physical environment includes climate, topography, geology, soils and surface/groundwater. The social environment includes existing and proposed development and the built components of the environment that alter or manage the quantity and quality of stormwater (Figure 2). The cultural environment includes modern, historic and archaeological heritage features that retain the evidence of human activity. The natural environment includes terrestrial and aquatic habitats and species as well as environmentally significant or sensitive features and areas. Section 2 of the Design Criteria Memo (Appendix D) provides additional detail about the baseline conditions of Parksville Community Park.

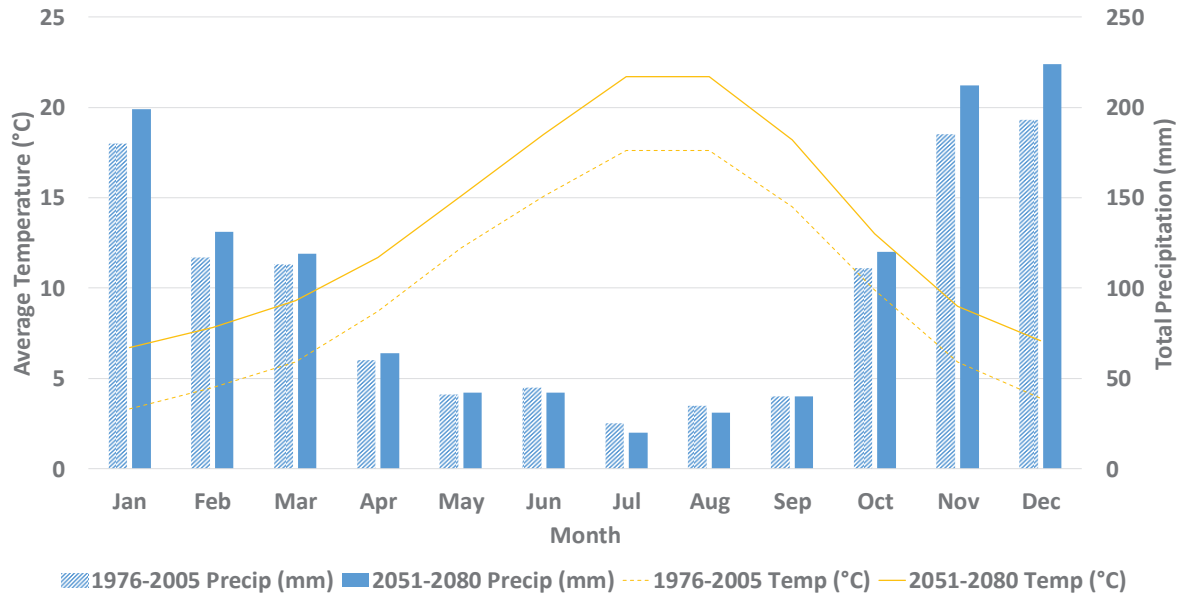
**Figure 3.** High Carbon Climate Change Projections for Parksville, BC (Prairie Climate Centre 2019)

Climate change in Parksville and across Canada has multiple implications for how we design, build and live in our cities. The first step for considering climate change in community plans is to estimate the climate change projections within each community. Key changes to anticipate in Parksville include wetter falls and winters as well as drier and much warmer summers, as illustrated by the projections in Figure 3. These anticipated climate changes in Parksville will introduce or exacerbate multiple risks to communities, built infrastructure and the natural environment.

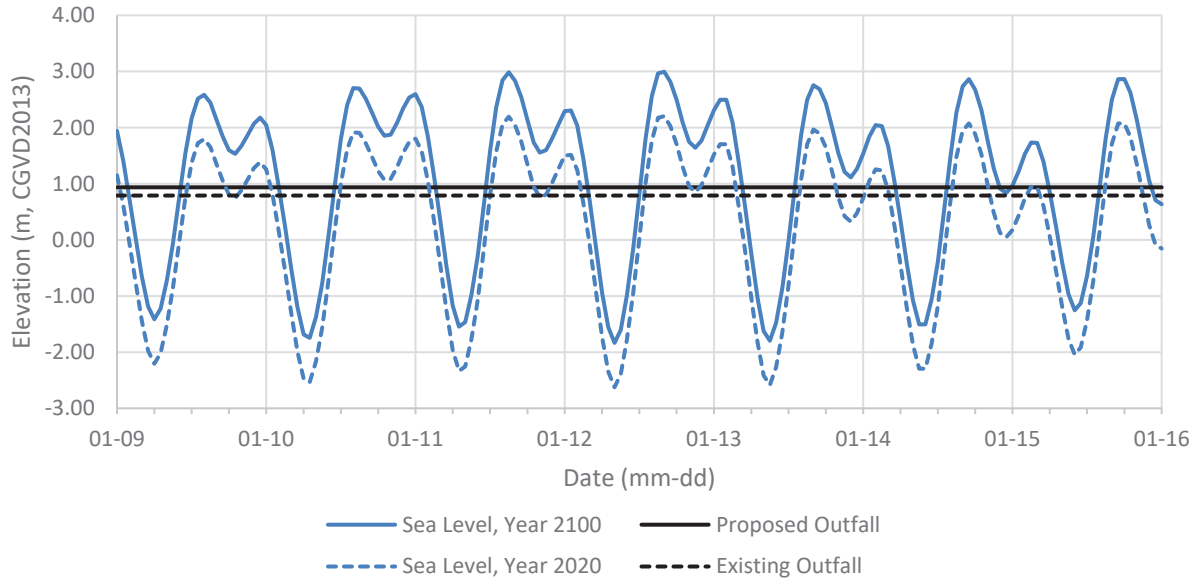
**Figure 7.** Existing and Future Sea Level Relative to Storm Sewer Outfall (Adapted from Northwest Hydraulics Consultants, 2020b)

As part of the SWMMP, Northwest Hydraulics Consultants (NHC) conducted a study to assess sea level under existing and future climate conditions, considering the effects of global SLR on tides and storm surge, as well as wave effects. Future, late-century projections were estimated based on applicable guidelines from the BC Ministry of Environment (BC MOE 2018) and include considerable uncertainty. NHC also developed a time series of sea water levels from September 2019 to April 2020 based on measured levels at Point Atkinson transformed to the project site. The time series, included in the stormwater modeling, includes the measured astronomical tide as well as residuals from storm surge and wind/wave set-up (Northwest Hydraulics Consultants 2020a). Figure 7 illustrates the time series shifted to account for regional SLR by year 2100 (+0.79 m) relative to the Park's existing storm sewer outfall and a new outfall which was recently installed, but not connected, as part of shoreline improvements. Sea levels will back up into the Park's stormwater management system through the outfall and will submerge parts of the contributing system under extreme sea levels. This effect will occur with increasing frequency and duration under future climate conditions due to SLR, even when the system is connected to the new outfall.

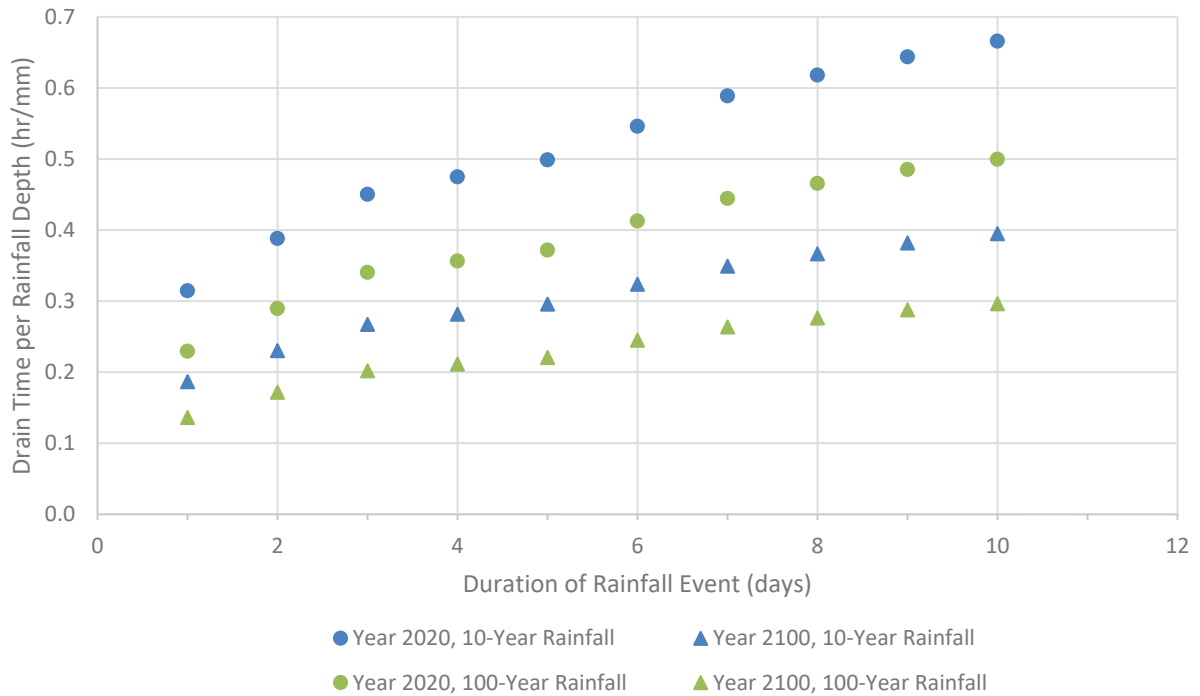
**Figure 8.** Design event drain times based on outfall elevation, tidal elevation fluctuations and event rainfall depth and duration

Combining the tidal timeseries with the outfall elevation of the stub outfall, the free outfall time for the duration of design storm events ranging from 6 hours to 10 days was calculated. When compared, the drain time for rainfall depths associated with each design event are illustrated in Figure 8.

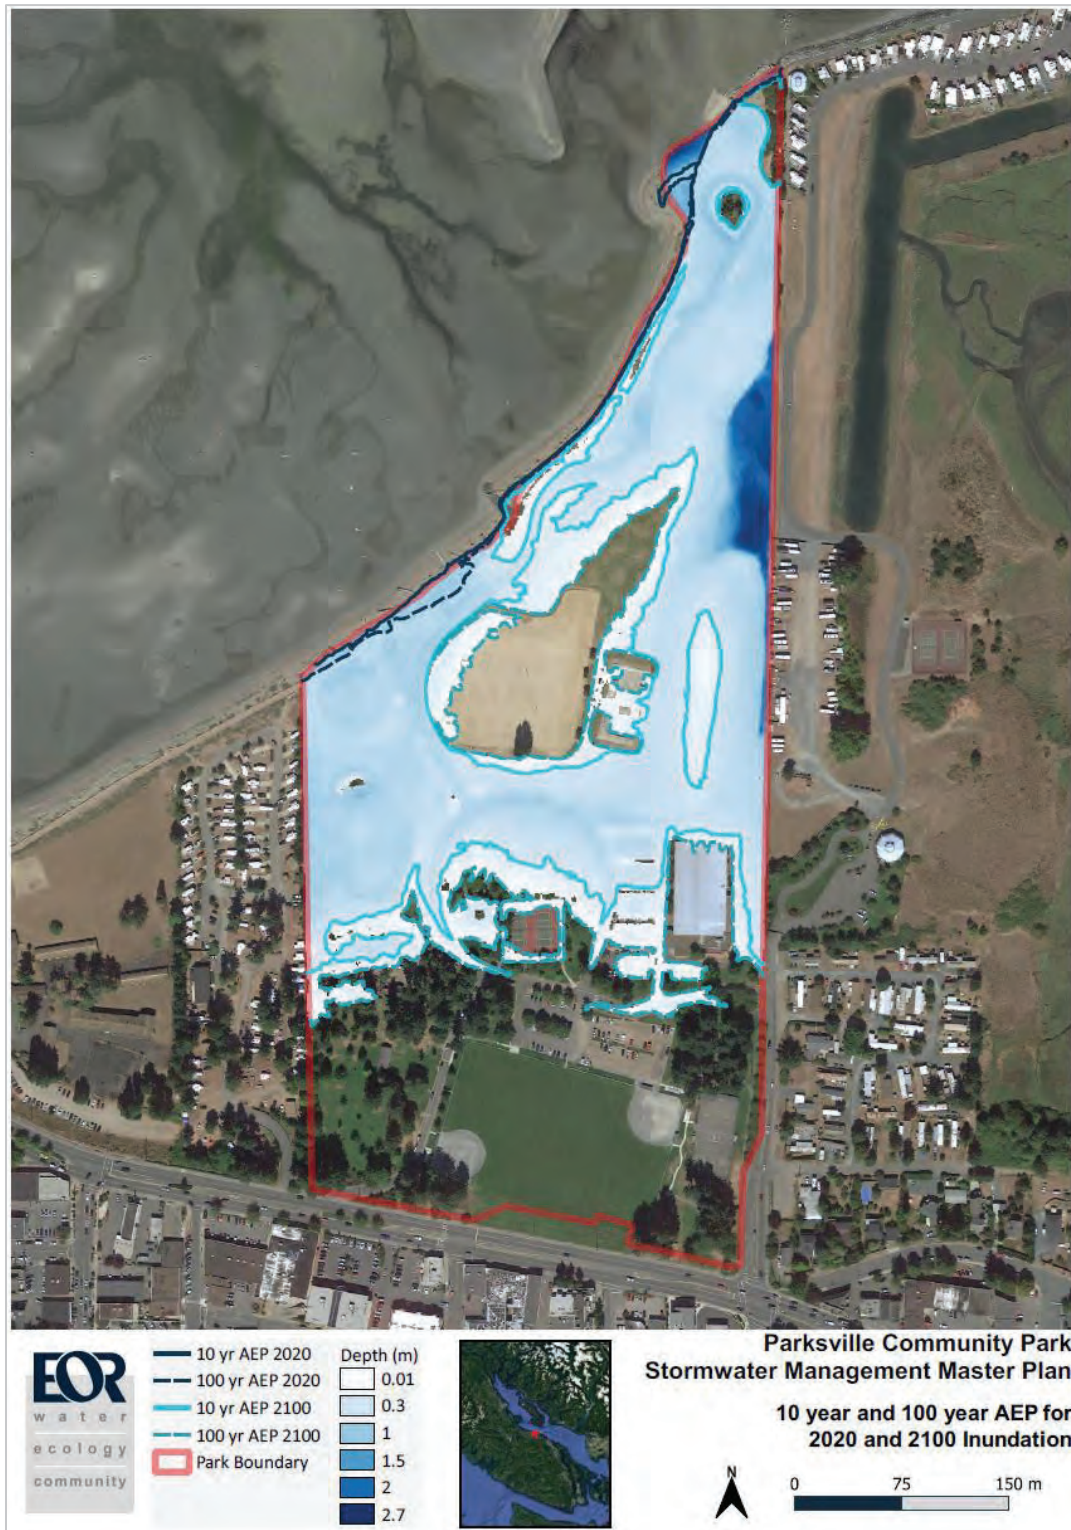
**Figure 9.** Coastal Inundation Mapping for Year 2020 and Year 2100 (adapted from Northwest Hydraulics Consultants 2020b)

NHC identified the late century design water levels (Table 3) with 10, 100 and 200 year annual exceedance probabilities based on joint probabilities of tides and storm surge, and including global SLR (+1 m by 2100) and local uplift (0.21 m by 2100) due to isostatic rebound, tectonic uplift and/or sediment consolidation (Northwest Hydraulics Consultants 2020b). These design water levels represent ‘still water level’ during extreme events and do not include wave effects. Significant coastal inundation of the Park is likely to occur by Year 2100, based on the existing park topography relative to the design water levels, is shown in Figure 9 for 10-year and 100-year return periods. Present-day inundation will be limited to the beach. The duration of park inundation due to coastal flooding will typically be two to three hours due to the astronomical tides, however the ability of the coastal flood water to recede within the Park depends on drainage infrastructure (Northwest Hydraulics Consultants 2020b). Drainage infrastructure proposed in Section 5 is able to fully discharge expected coastal inundation waters. NHC assumed neighbouring properties will be raised to prevent coastal inundation via overland flow from those properties (G. Lamont personal communication, July 23, 2020).

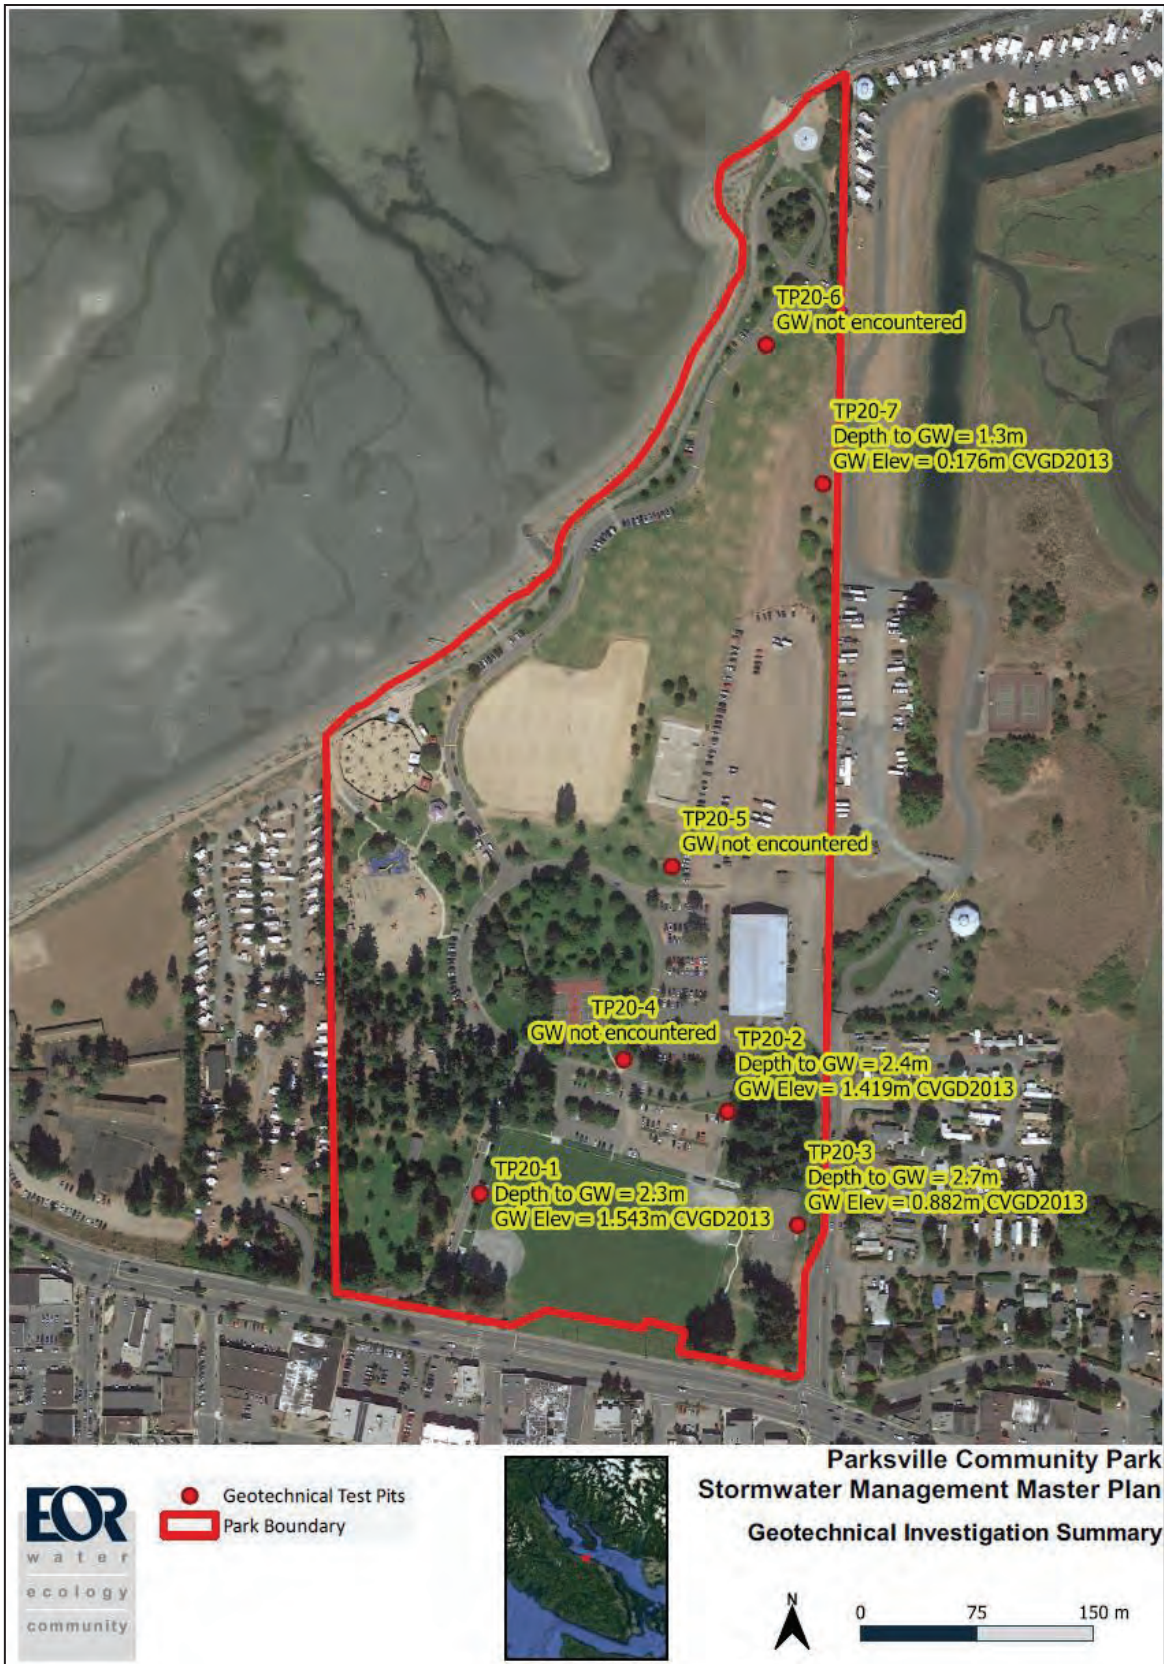
Figure 11. Groundwater elevations observed during Geotechnical investigation

The geotechnical investigation conducted by Thurber Engineering Ltd. characterized depth to groundwater at the time of the investigation (May 14, 2020). As shown in Figure 11, no groundwater was encountered at three of the test pits (TP20-4, TP20-5, TP20-6). Depth to groundwater in the three southernmost test pits (TP20-1, TP20-2, TP20-3) ranged from 2.3 to 2.7 m. The shallowest groundwater was observed 1.3 m below ground in the dry basin located northeast of the curling rink on the eastern boundary of the Park (TP20-7), which was also the lowest topographic point investigated. Additional information on the geotechnical investigation is provided in Appendix D.

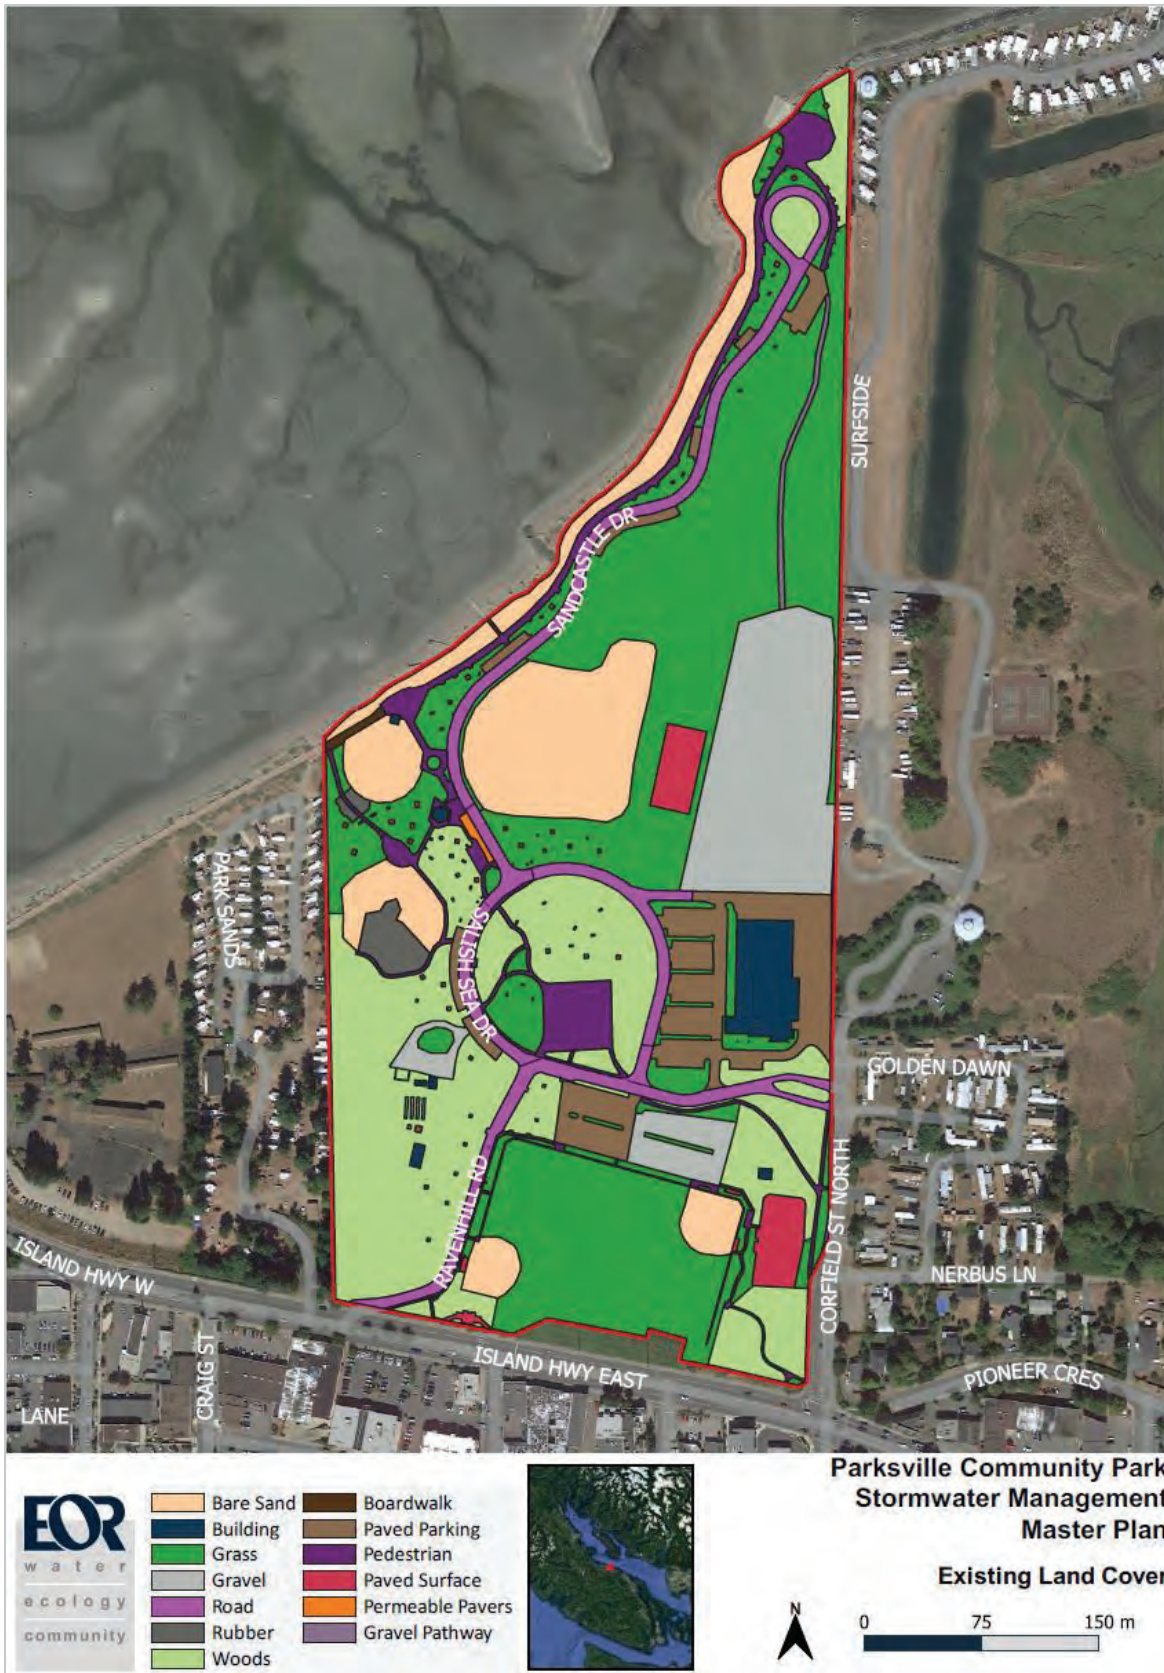
Figure 12. Existing Land Cover

Land cover in the Park includes buildings, parking lots (paved and gravel), roads, trails, a skate park, beach volleyball courts, playgrounds, baseball diamonds, tennis courts, a basketball/lacrosse court, a sand castle exhibition space, a splash pad, a tree arboretum, and other open spaces, as shown in Figure 12. Anticipated improvements in the Park that will increase impervious cover were compiled from City staff, the Parksville Community Park Master Plan (CPMP) and the ongoing Pedestrian Connections and Circulation Plan, and include an amphitheatre, extension of Sandcastle Drive and pedestrian trail improvements, as shown in Figure 13. The proposed layout of various improvements is subject to change, but overall, the future improvements are expected to increase the impervious cover of the Park from approximately 5.6 to 5.9 ha (31 to 33%).

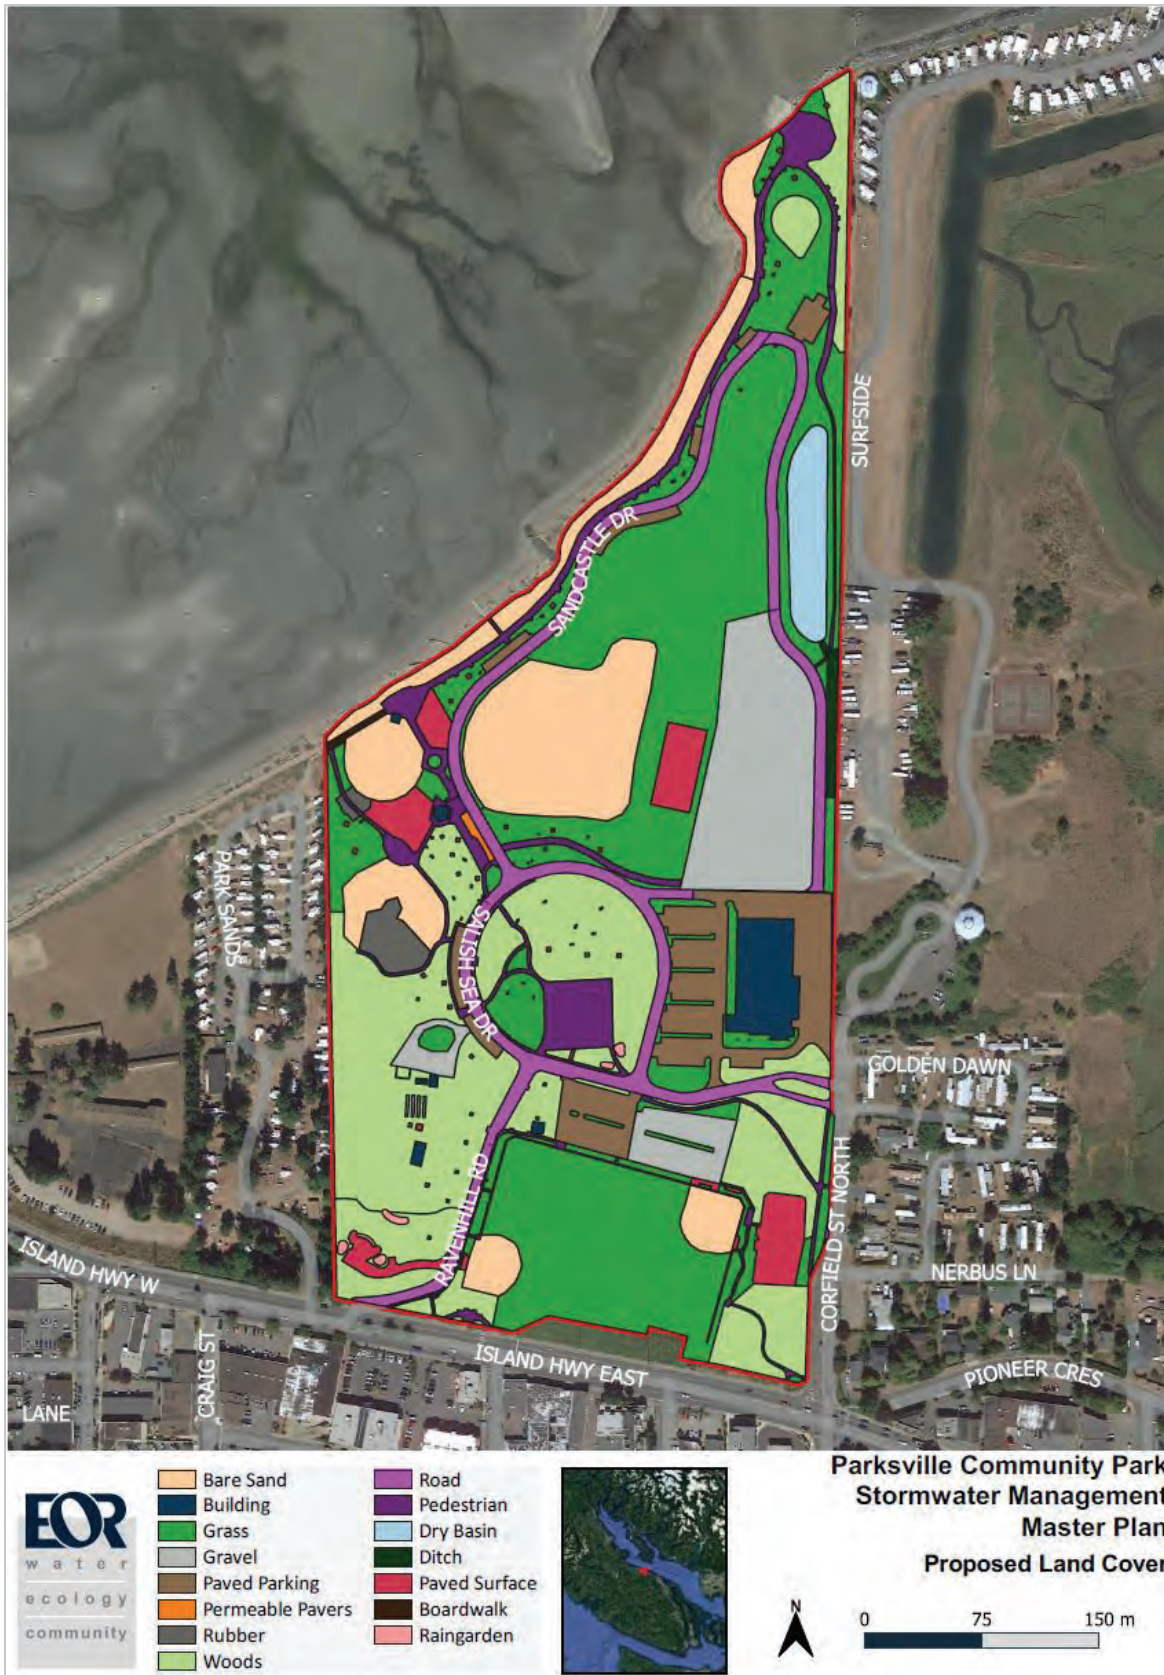
Figure 13. Future Land Cover

The Parksville Community Park Pedestrian Connections Plan, under development at the time of writing, informed the future land cover within the Park illustrated in Figure 13. The improvements proposed through the Official Community Plan, Parksville Community Park Master Plan, Parks Trails and Open Spaces Master Plan, are reflected in the preliminary Parksville Community Park Pedestrian Connections & Circulation Plan concept illustrated in Figure 15.

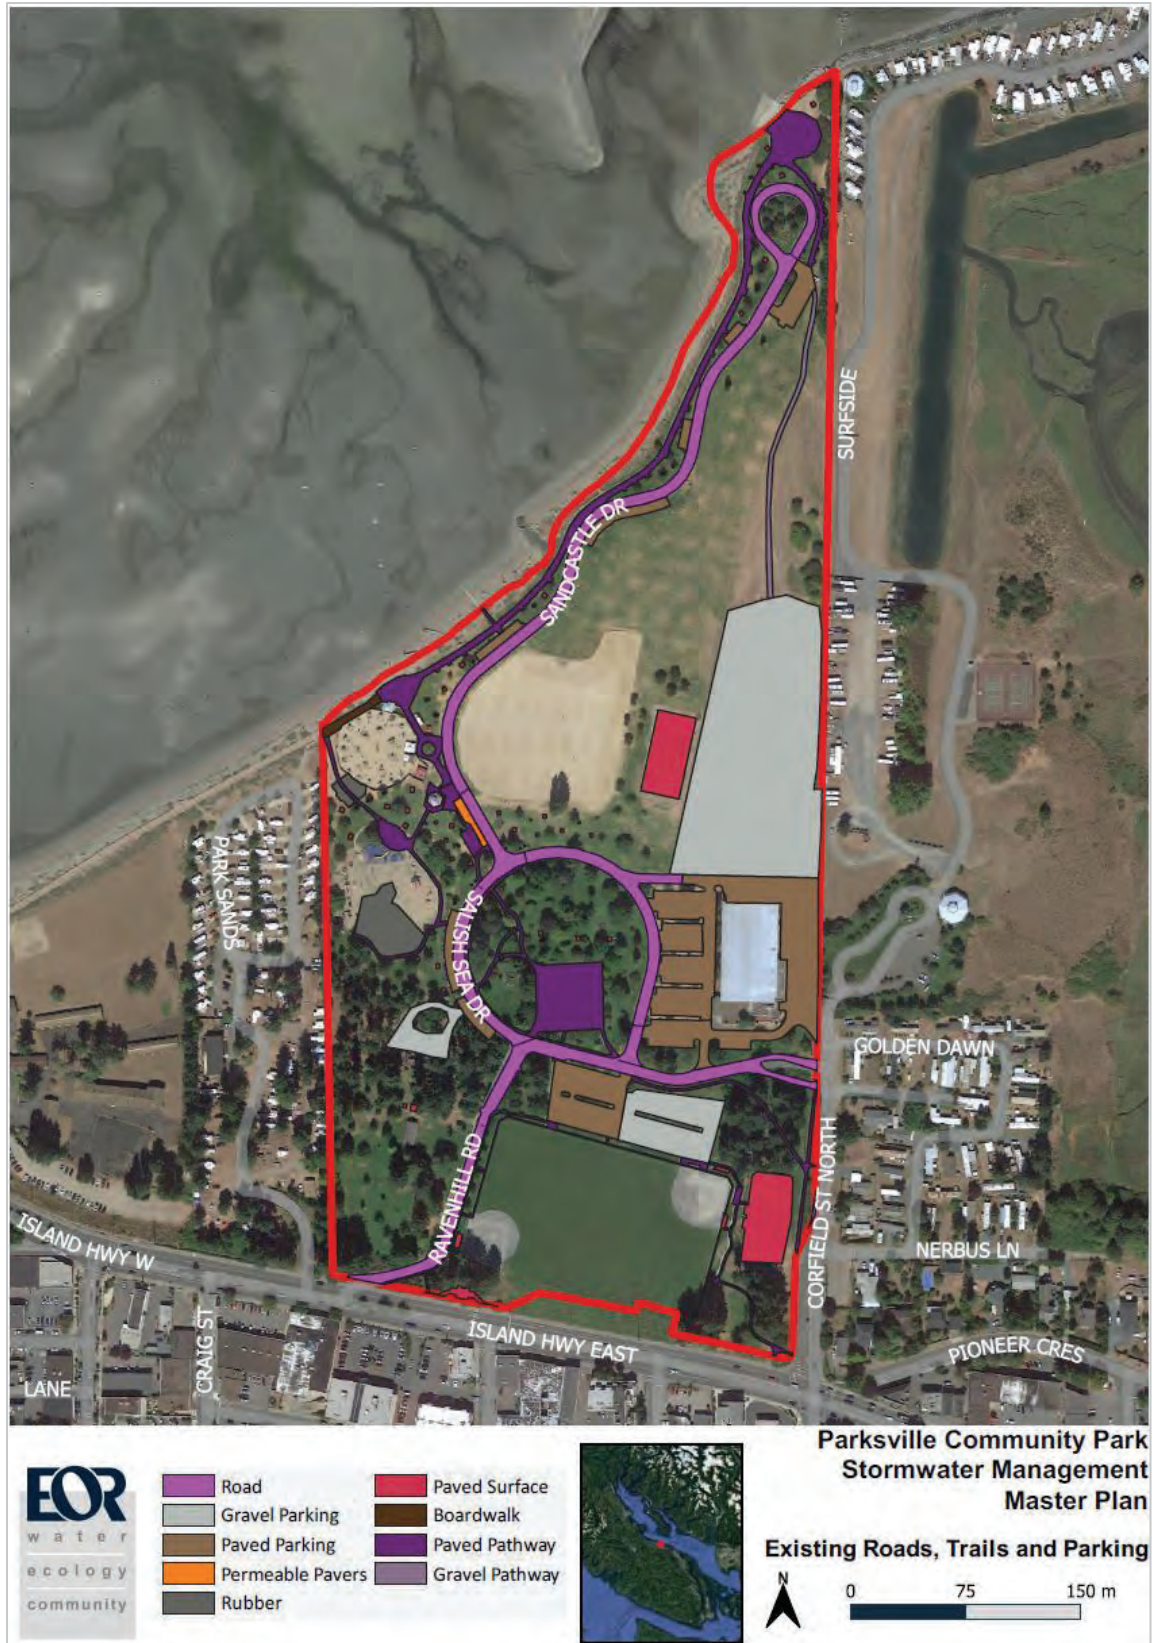
Figure 14. Existing road and trail infrastructure in Parkville Community Park

The existing road, parking and trail infrastructure in the Park is illustrated in Figure 14. The three roads in the Park are Sandcastle Drive, Salish Sea Drive and Ravenhill Road. The three main parking lots in the Park are the paved and gravel lot by the sports field, the paved lot west of the curling rink, and the large gravel overflow lot north of the curling rink. Additional parking is provided on the East side of the curling rink and in smaller, roadside parking along Sandcastle Drive. City staff noted some historic issues with accelerated asphalt deterioration in areas with frequent nuisance flooding issues. The City installed a section of permeable pavers in one of the roadside parking areas in 2015, which is functioning well so far. There are several limitations for pedestrians in the Park based on gaps between sidewalk and trail networks. The City sweeps the streets in the Park every two weeks.

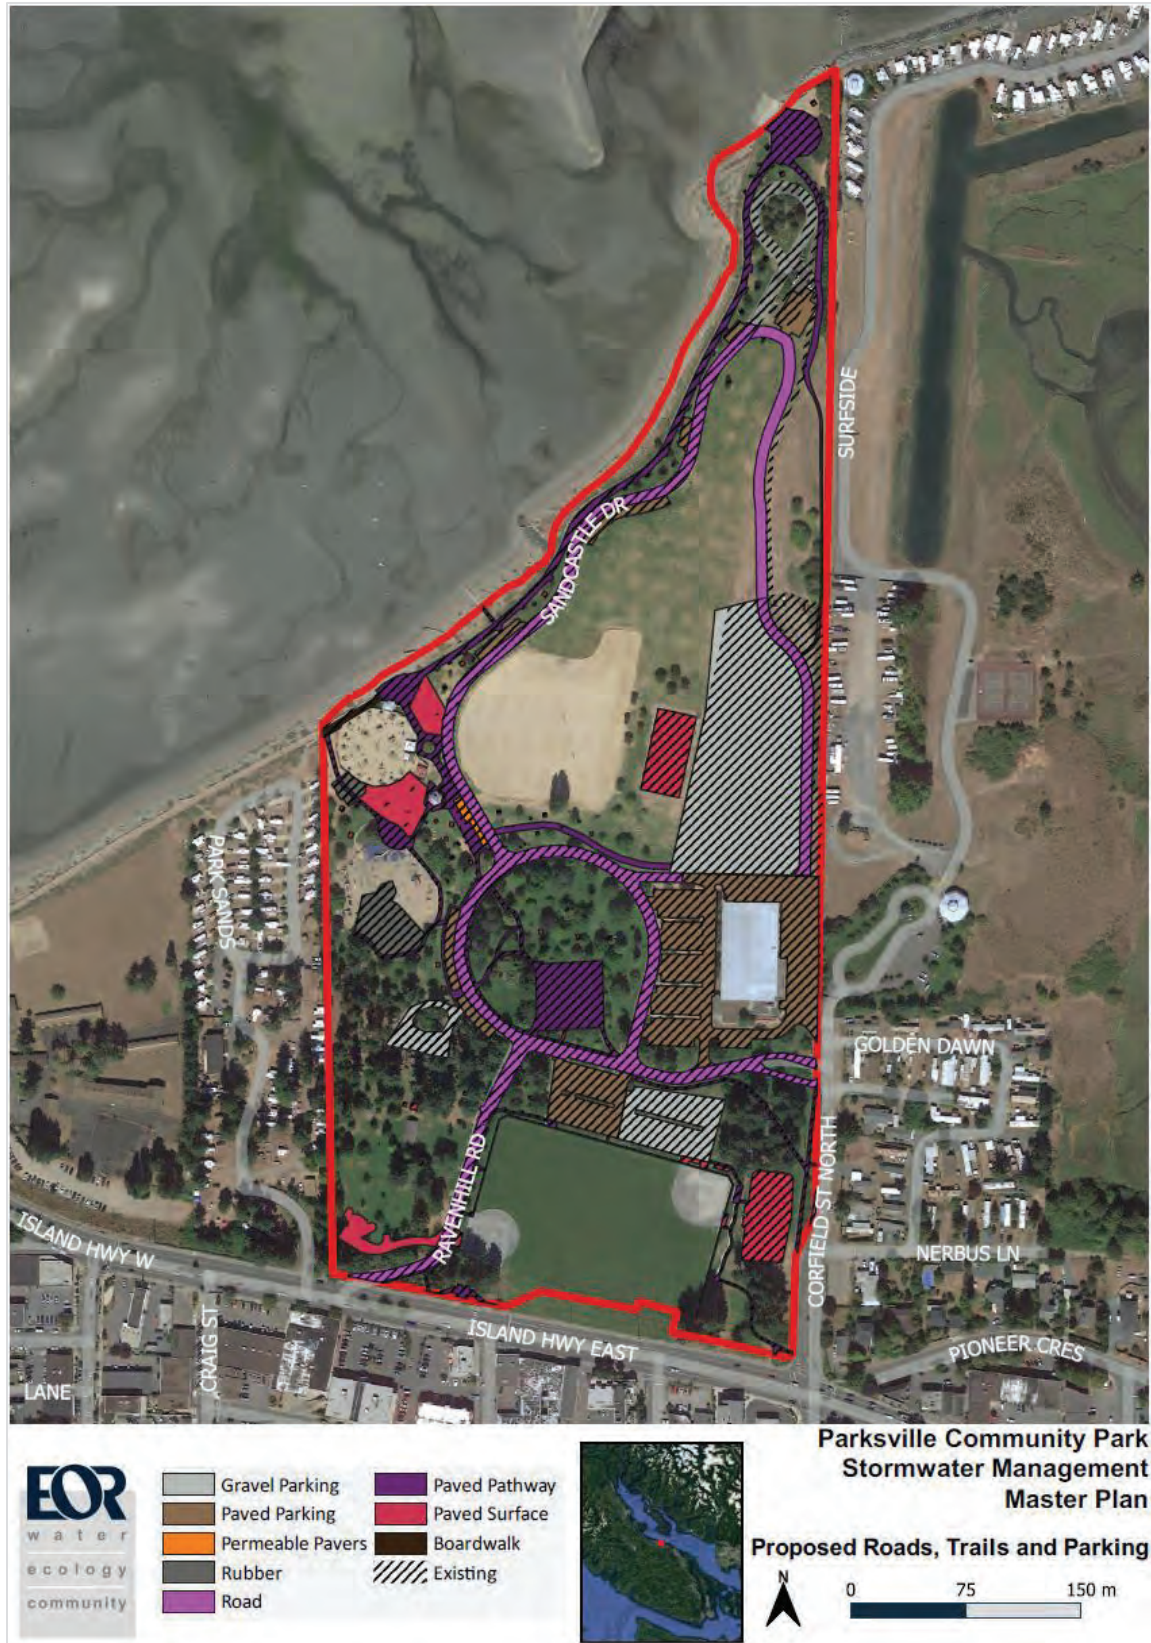
**Figure 15.** Future road and trail infrastructure based on preliminary discussions around the Parkville Community Park Pedestrian Connections and Circulation Plan

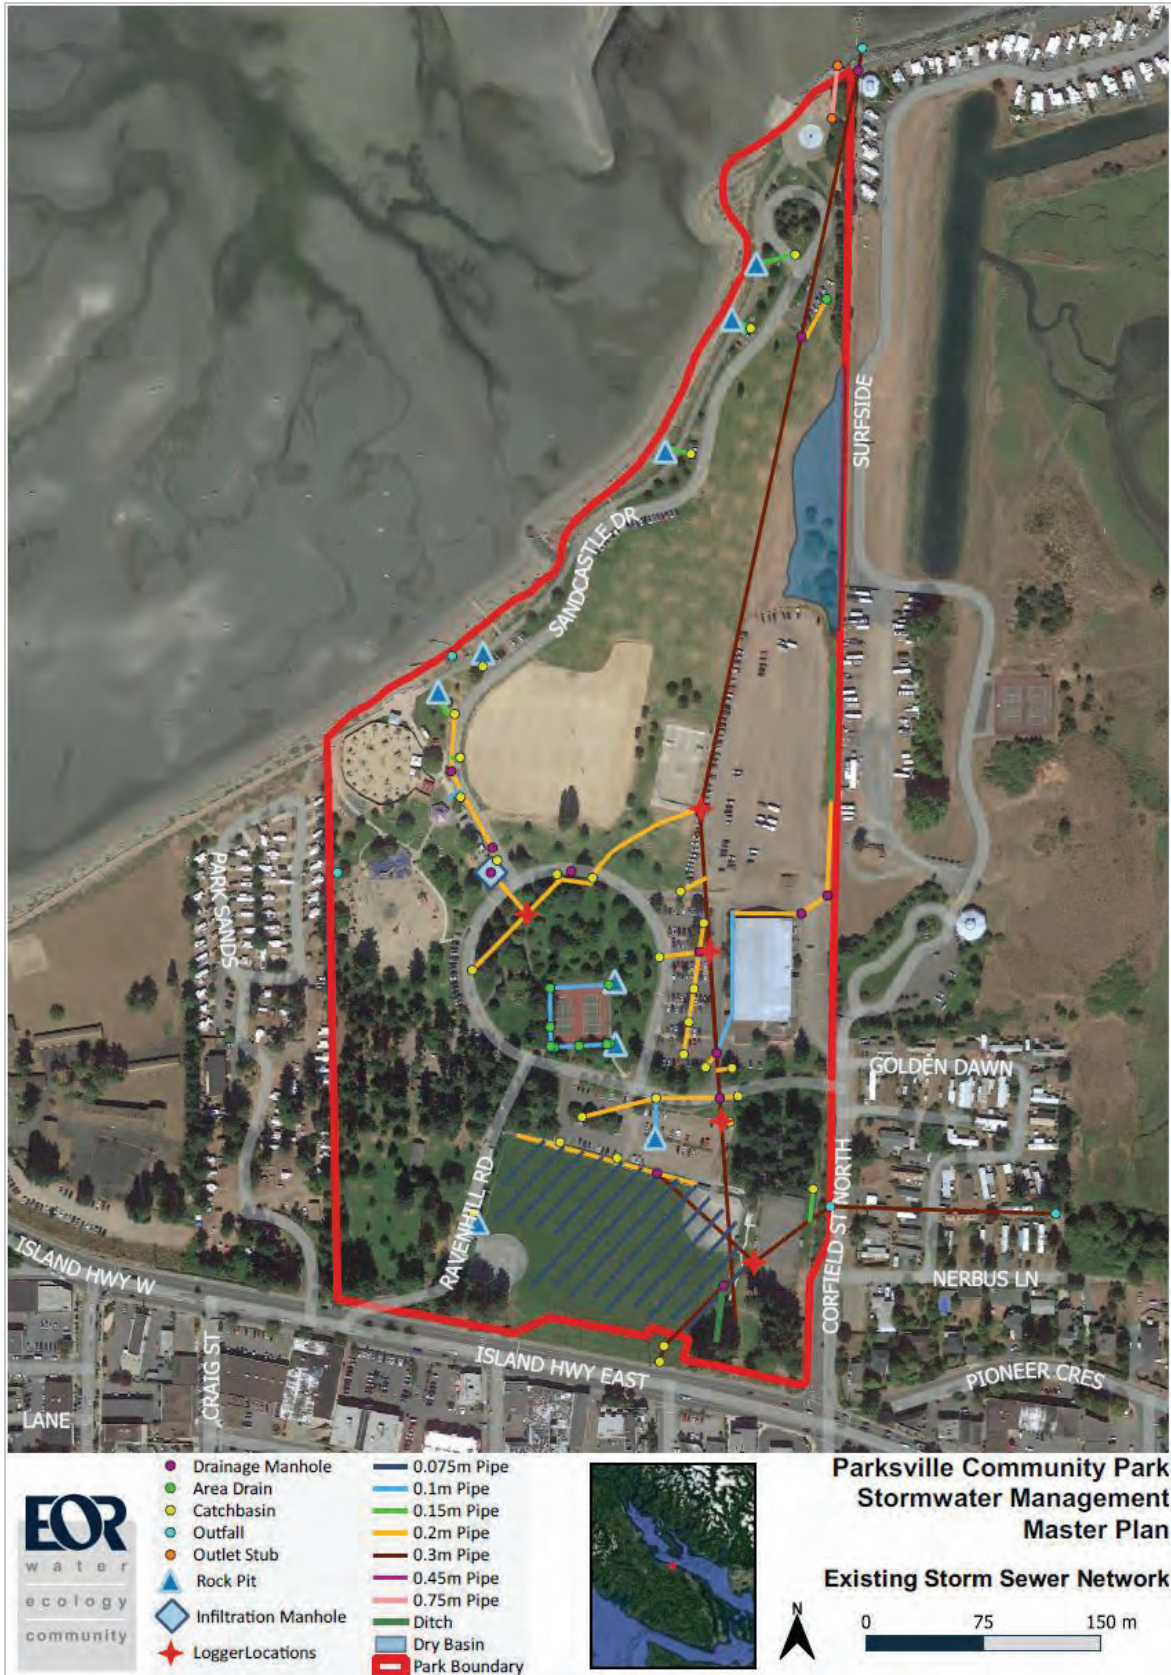
Figure 17. Existing Stormwater Management System

The major stormwater catchments throughout the Park are illustrated in Figure 16. An inventory of the stormwater management infrastructure in the Park is summarized in Table 4 and illustrated in Figure 17. As shown in Figure 17, an outfall stub with larger capacity than the existing storm sewer was installed at Arbutus Point during shoreline stabilization improvements designed by NHC and built in 2017 (Northwest Hydraulics Consultants Ltd. 2017). The basic design parameters of the pipe (e.g. location and diameter) were selected by the City and the outfall invert elevation was set to the level of the beach at the base of the slope, approximately 0.15 m above the existing outfall. The City has noted that the existing outfall periodically clogs with sediment and debris, however it is unknown to what extent the new outfall will mitigate this issue.

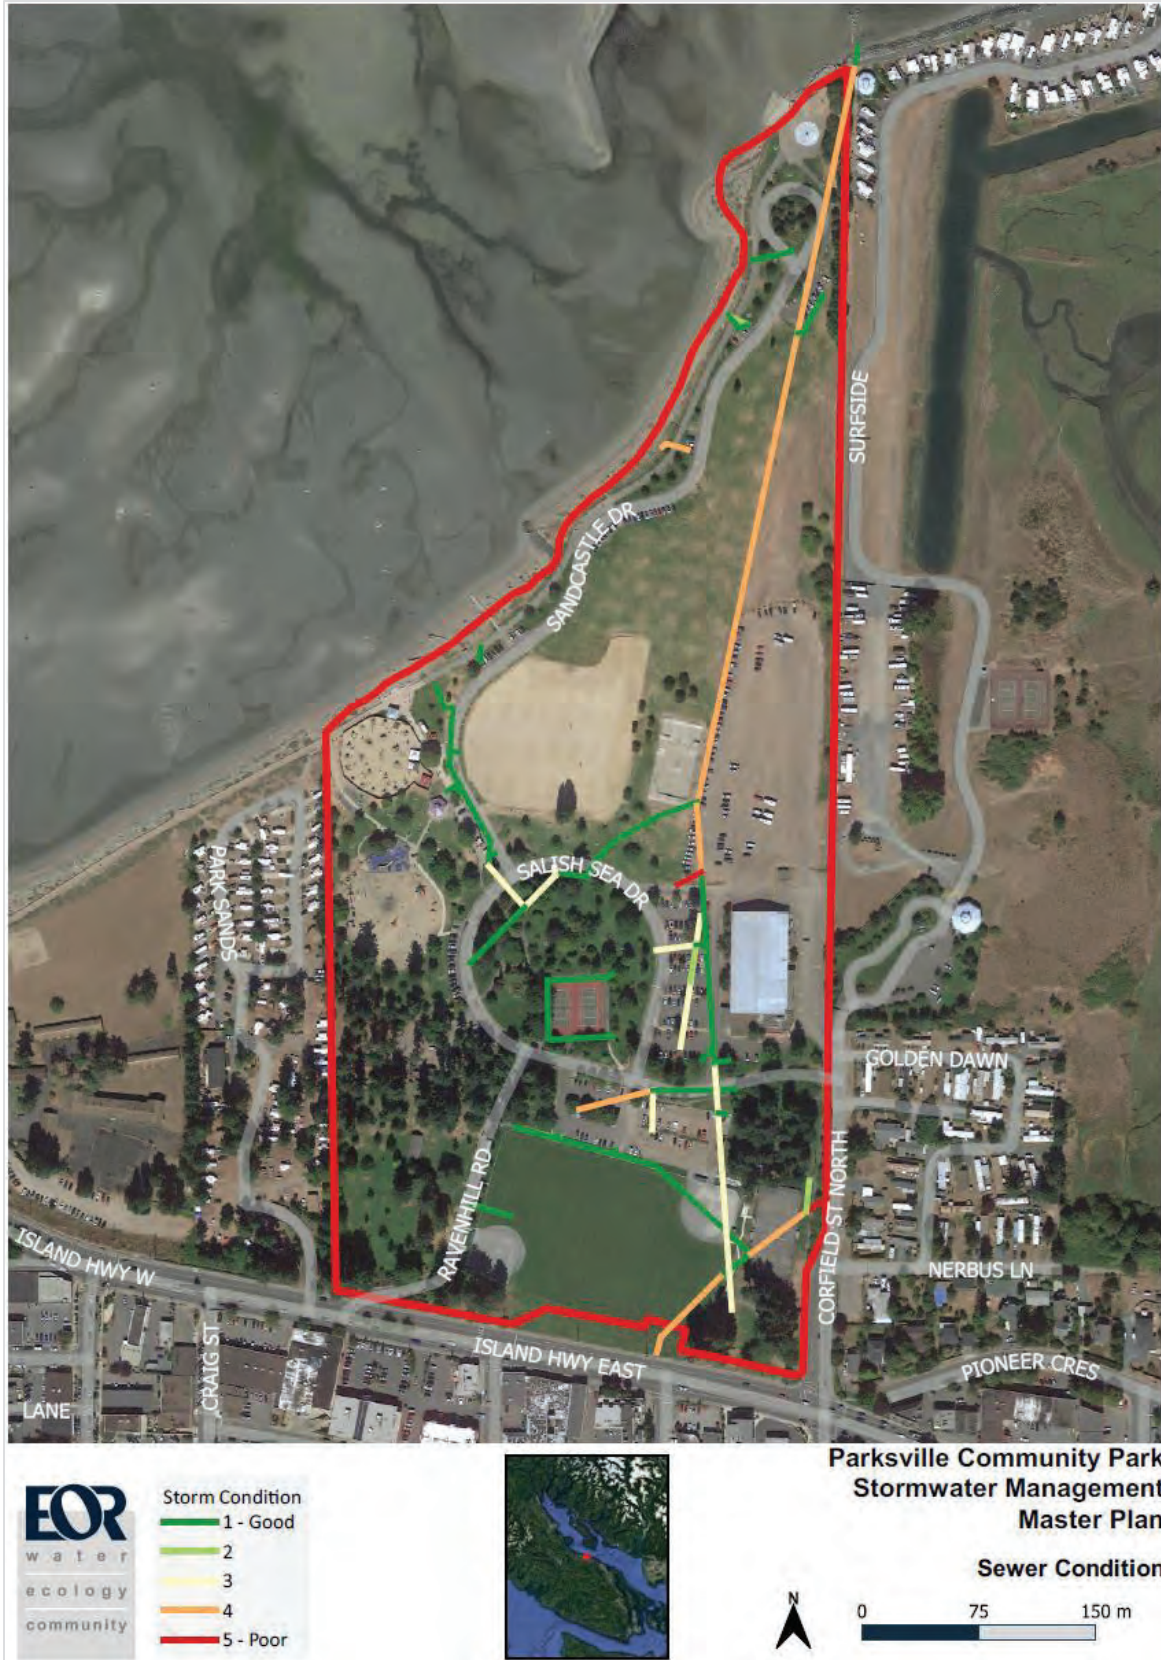
Figure 18. Estimated Sewer Condition

The age of the stormwater management infrastructure is uncertain, however sewer conditions were considered based on CCTV inspections by Pipe-Eye Video Inspections (reports and digital video files provided to the City of Parksville Engineering Department). Sewer condition codes were assigned by Pipe-Eye Video Inspections based on findings observed on the CCTV videos. Sewer condition codes are from the North American Association of Pipeline Inspectors Sewer Condition Codes Index (NAAPI 2003) which uses the Water Research Centre (WRc) sewer conditions classifications (WRc 1993) outlined in Table 5. The codes assigned from the CCTV inspection, combined with the video records, were used to estimate a condition ranking for each pipe length using the ranking defined in (WRc 1993). This ranking is not weighted by risk of failure, nor are any financial implications associated with it. Approximately 1084 m (51 %) of the storm sewer network is asbestos cement. The estimated condition ranking is shown in Figure 18.

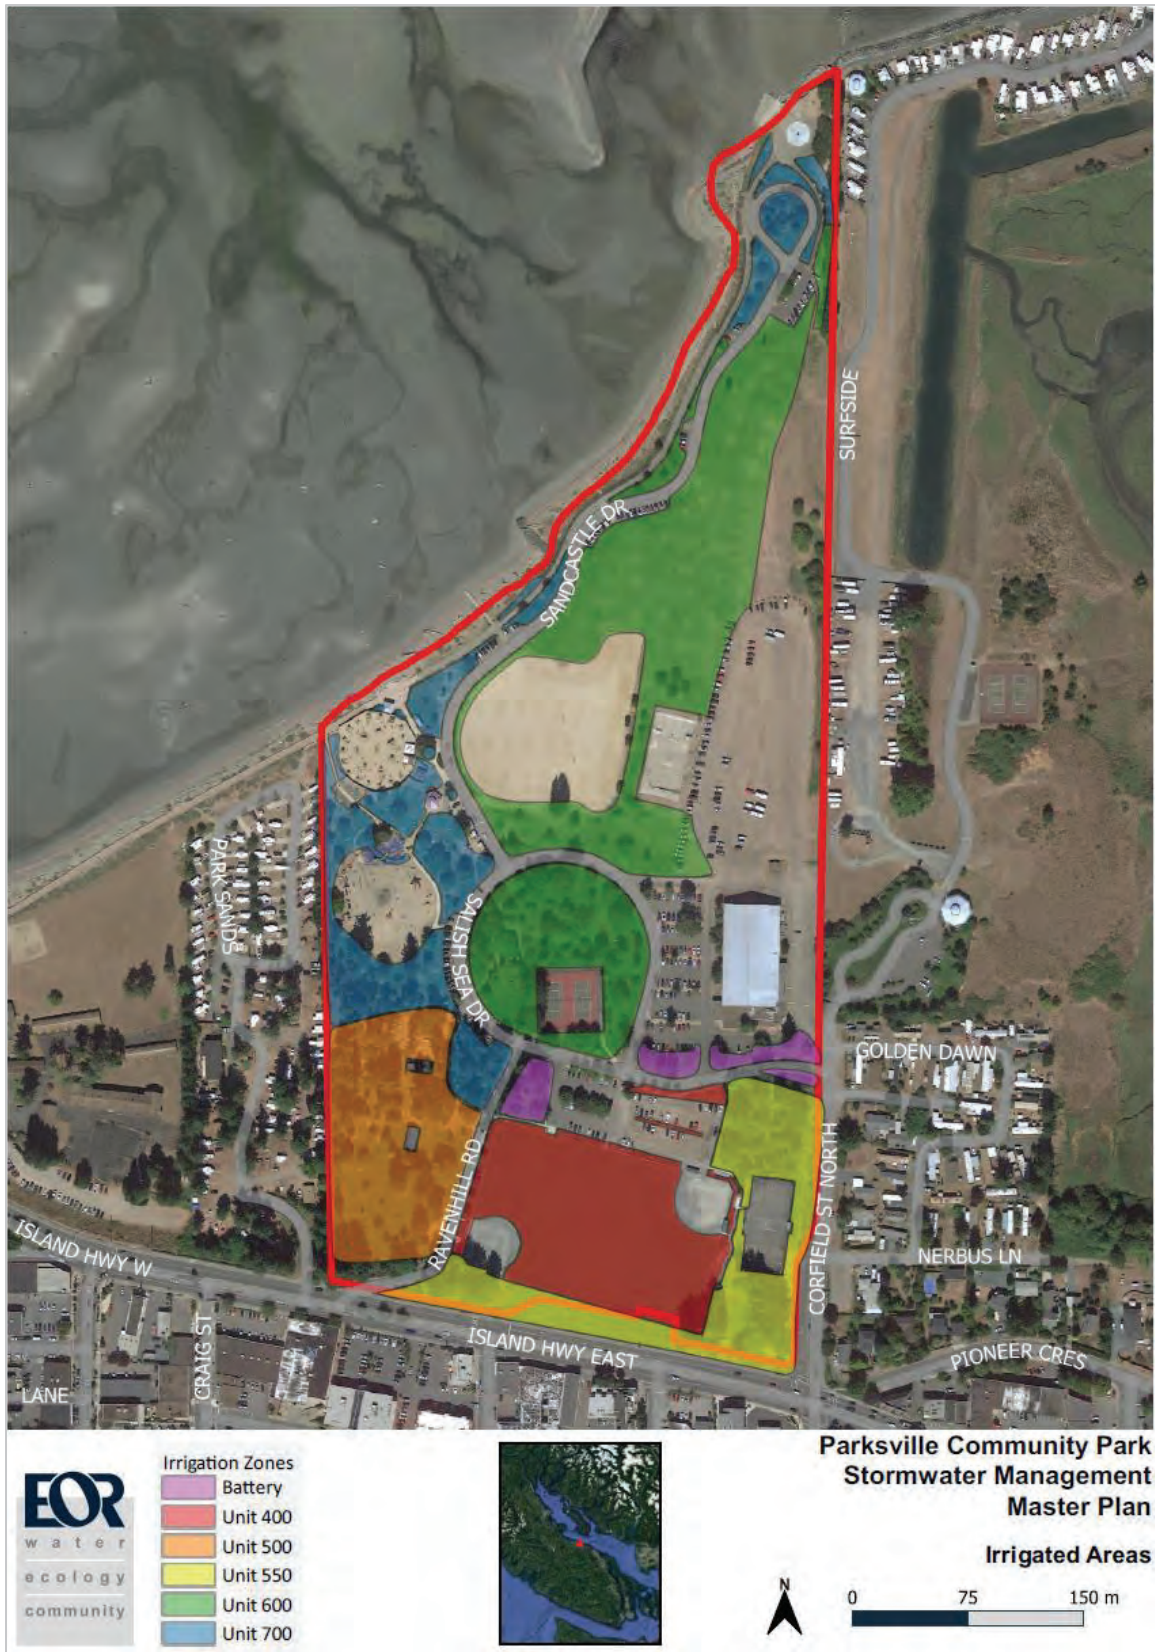
Figure 19. Irrigation zones in Parksville Community Park
