## 2. CURRENT AND FUTURE CONDITIONS

This section summarizes the future environment in the study area (Figure 1) relevant to stormwater management planning to maintain the expected level of service under future conditions. The environment of Parksville Community Park includes the physical, social, cultural, and natural environments. The physical environment includes climate, topography, geology, soils and surface/groundwater. The social environment includes existing and proposed development and the built components of the environment that alter or manage the quantity and quality of stormwater (Figure 2). The cultural environment includes modern, historic and archaeological heritage features that retain the evidence of human activity. The natural environment includes terrestrial and aquatic habitats and species as well as environmentally significant or sensitive features and areas. Section 2 of the Design Criteria Memo (Appendix D) provides additional detail about the baseline conditions of Parksville Community Park.

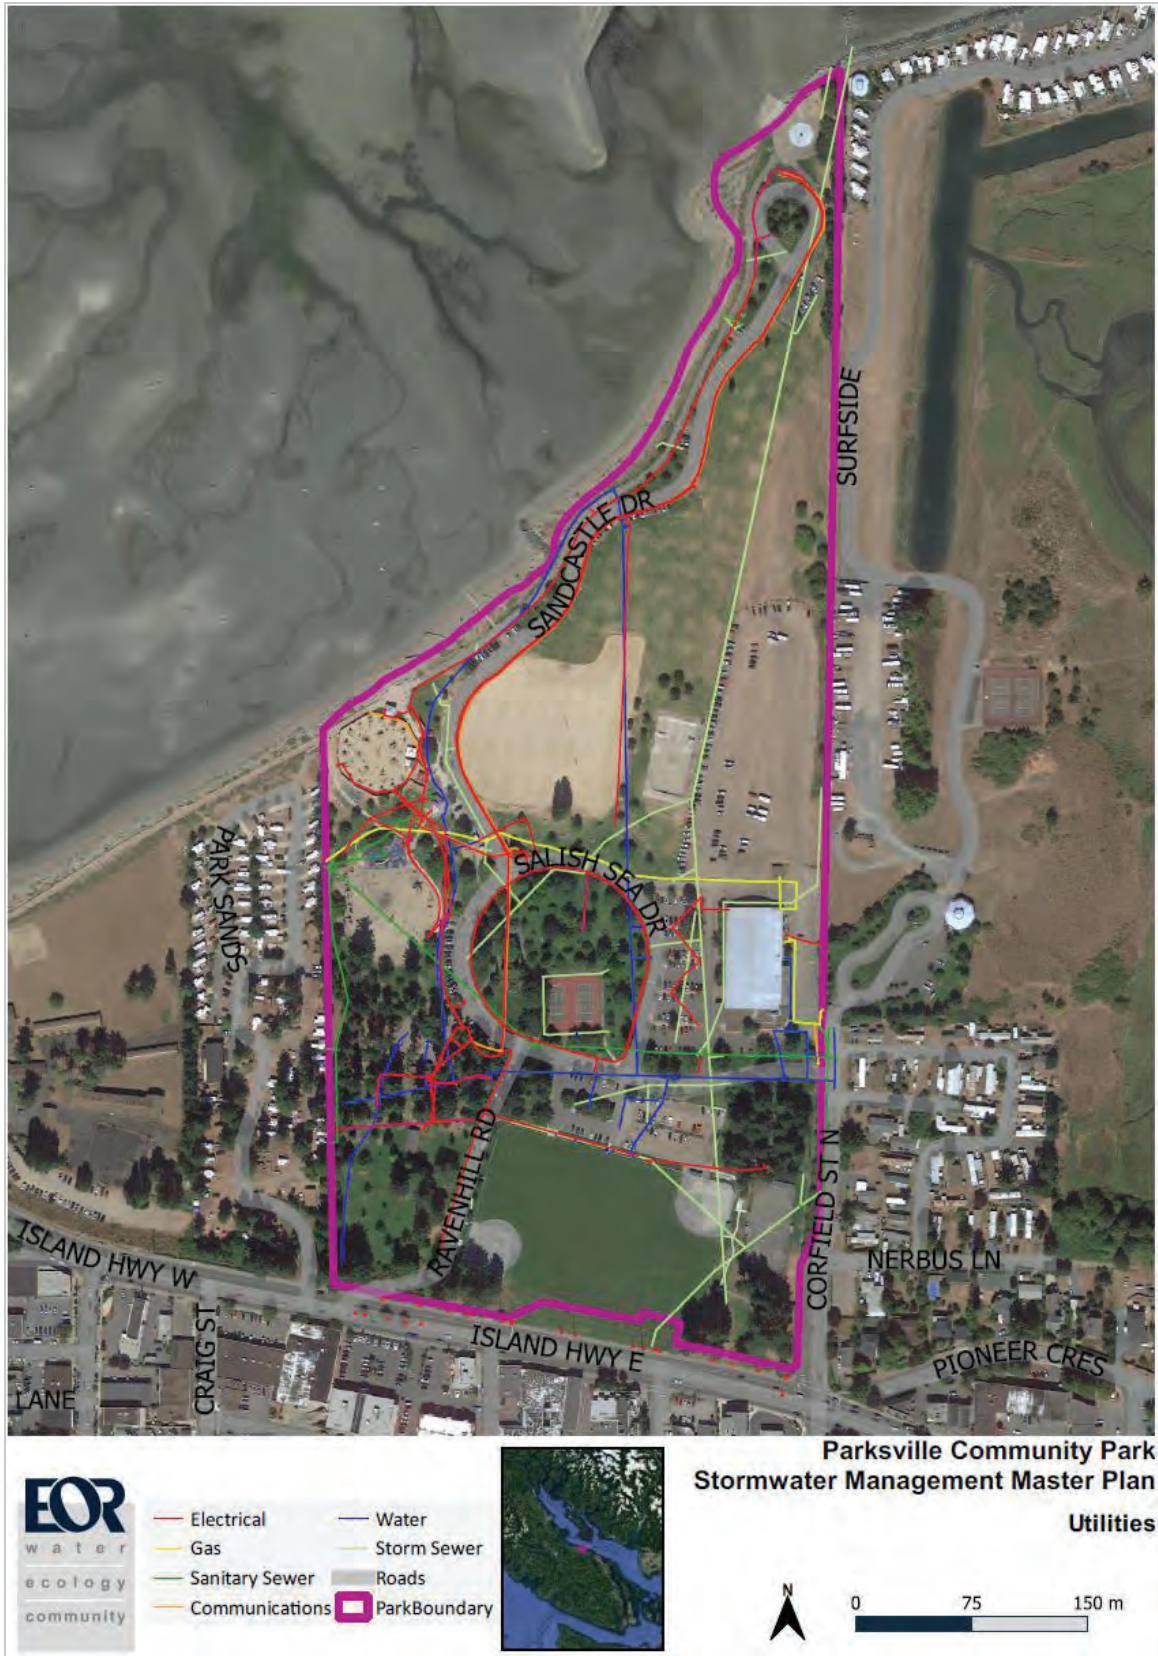
Figure 20. Park Utilities

Other utilities in the Park include sanitary, water (including irrigation), gas and electrical utilities. Key utility alignments are illustrated in Figure 20. The Park's underground irrigation system draws from the City's drinking water system, which was recently expanded to support on-going development in the region. The City irrigates approximately 11 ha (61%) of the Park year-round (see Figure 19) and is operated by staff based on precipitation recorded at the Parksville Operations Yard (City of Parksville). City staff estimate that the irrigation system applies over 38,000 m<sup>3</sup> of water annually at an equivalent cost of about \$73,000 (2020 dollars) using Bylaw 1320 - Water Service System Bylaw charge rate of \$1.9096/m<sup>3</sup>.
